"Full" Reserve Study

The Indian Peaks Resort Common Elements Winter Park, CO

Report #: 36564-0
For Period Beginning: January 1, 2020
Expires: December 31, 2020

Date Prepared: August 9, 2019

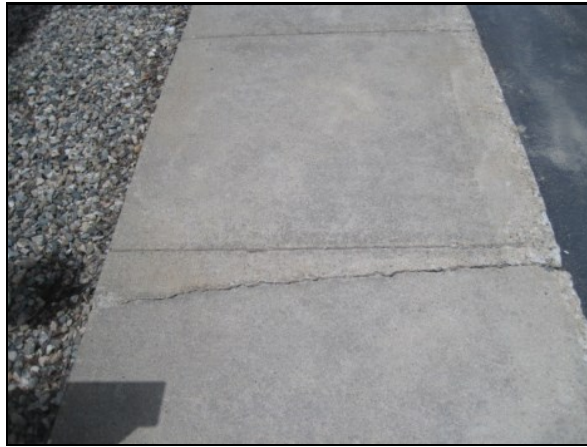
Useful Life:
5 years

Remaining Life:
2 years

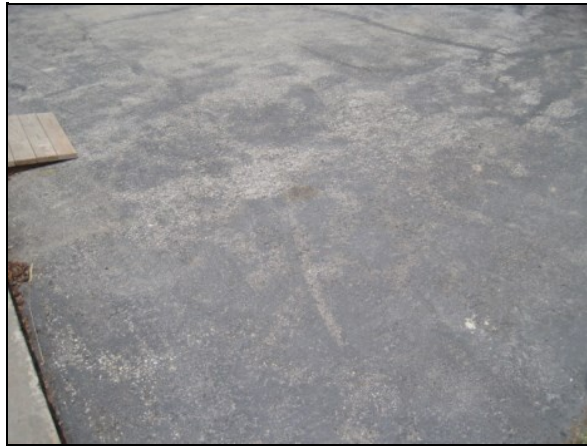
Useful Life:
2 years

Remaining Life:
0 years

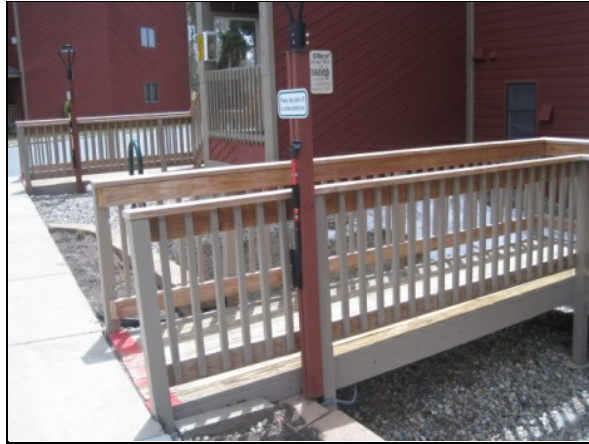
Useful Life:
5 years

Remaining Life:
3 years

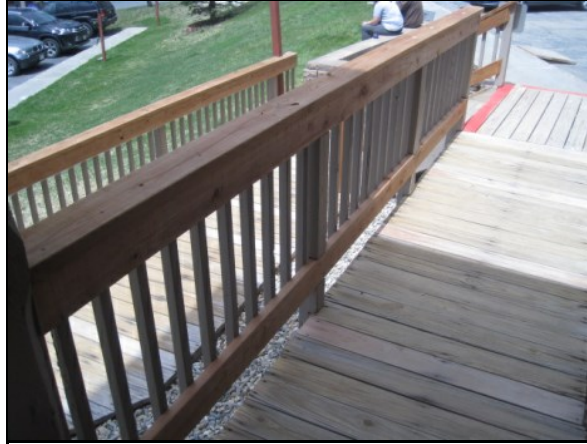
Useful Life:
25 years

Remaining Life:
23 years

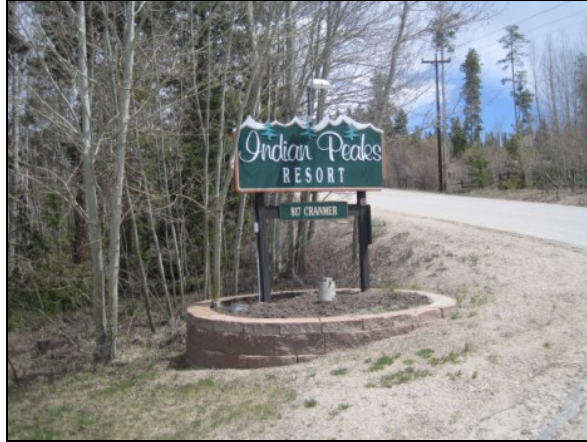
Useful Life:
30 years

Remaining Life:
6 years

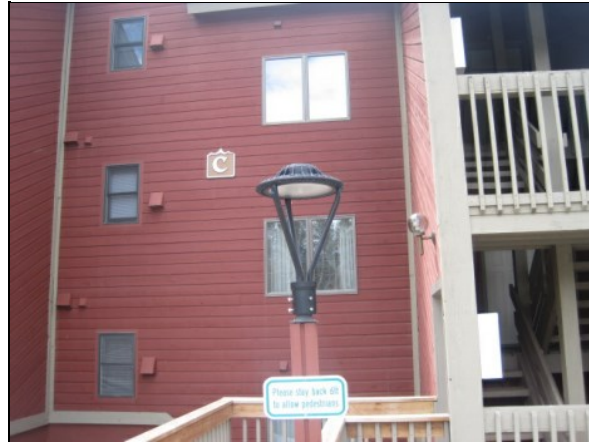
Useful Life:
30 years

Remaining Life:
29 years

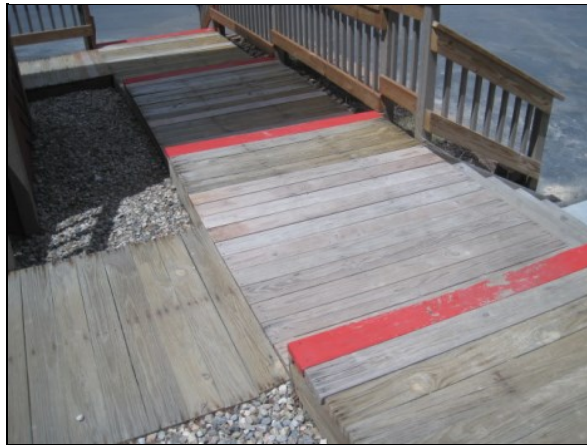
Useful Life:
5 years

Remaining Life:
1 years

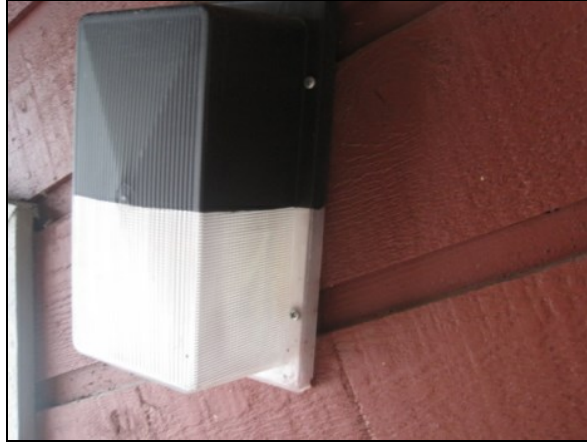
Useful Life:
25 years

Remaining Life:
0 years

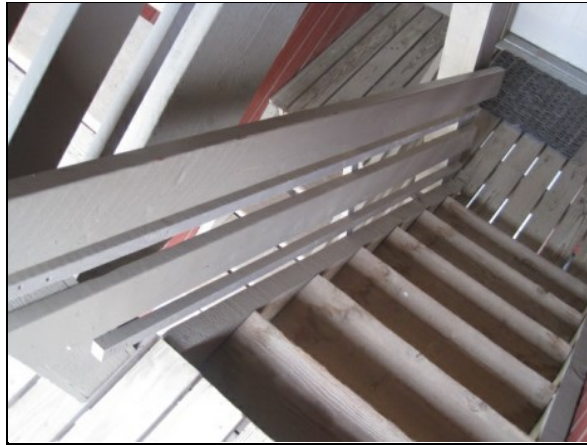
Useful Life:
5 years

Remaining Life:
2 years

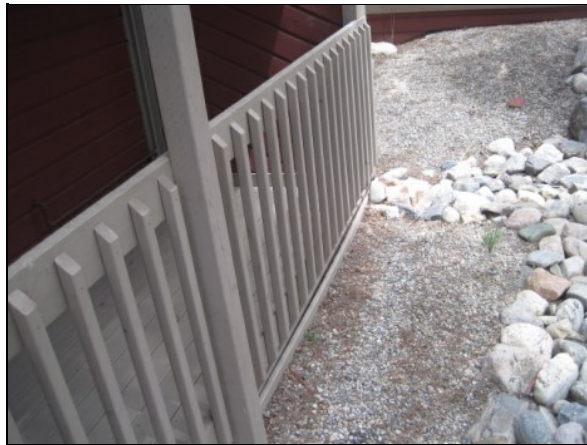
Useful Life:
30 years

Remaining Life:
11 years

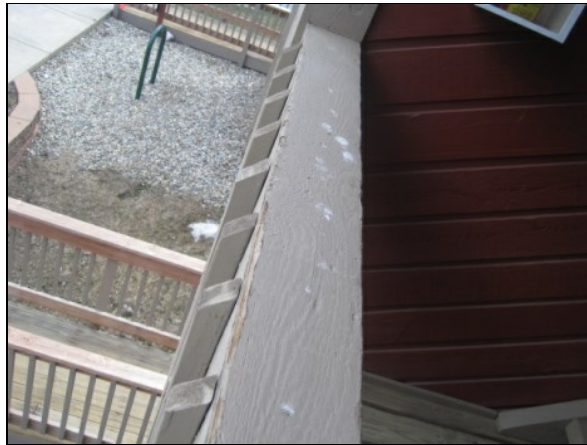
Useful Life:
30 years

Remaining Life:
11 years

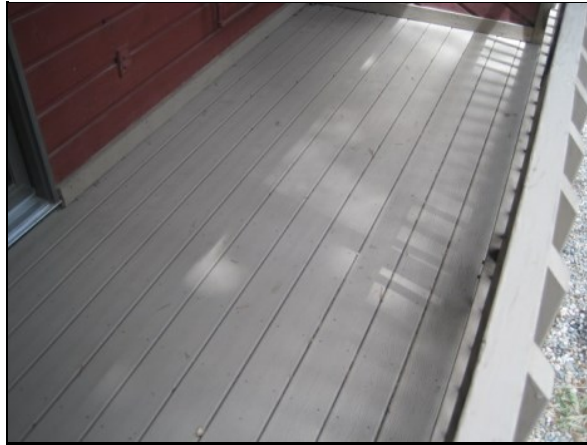
Useful Life:
5 years

Remaining Life:
0 years

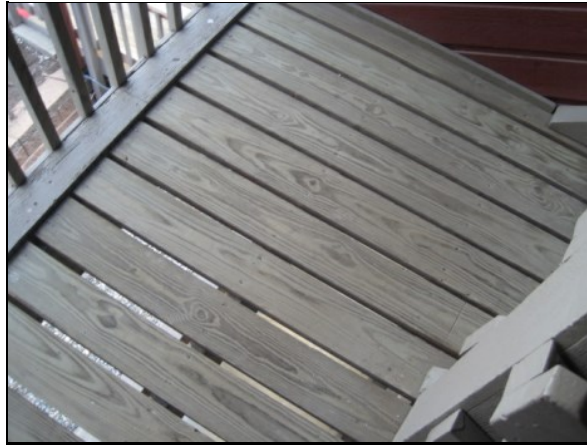
Useful Life:
5 years

Remaining Life:
0 years

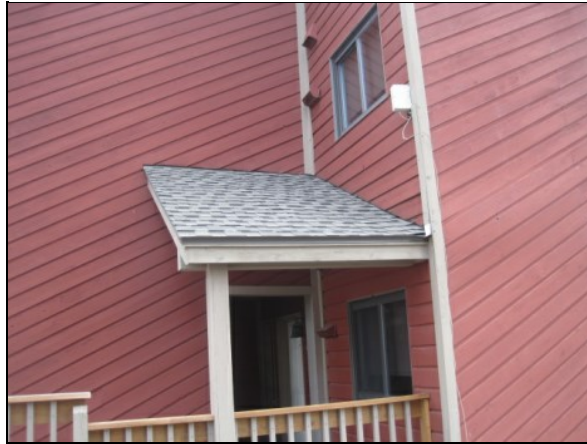
Useful Life:
55 years

Remaining Life:
16 years

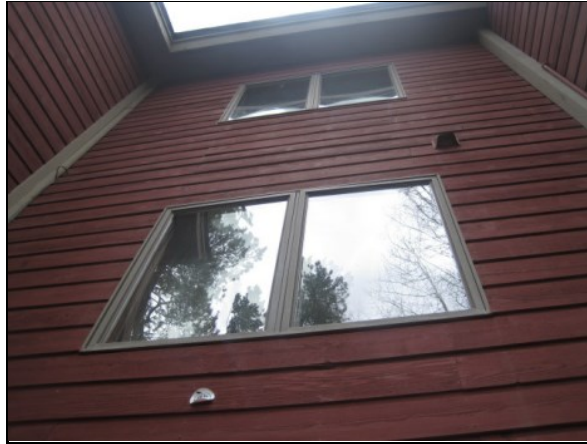
Useful Life:
30 years

Remaining Life:
4 years

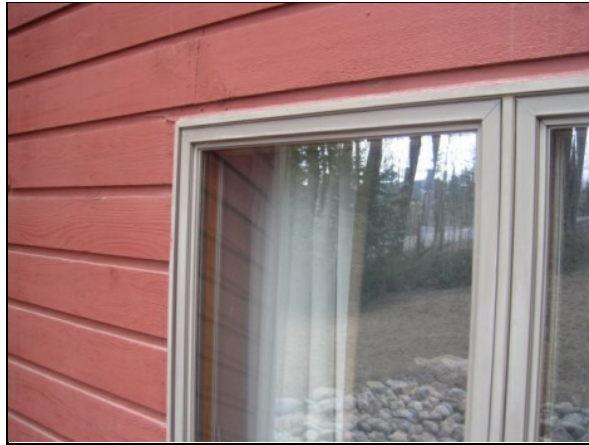
Useful Life:
30 years

Remaining Life:
4 years

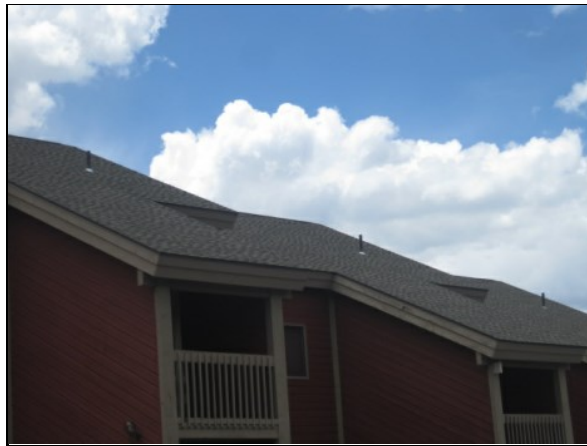
Useful Life:
20 years

Remaining Life:
18 years

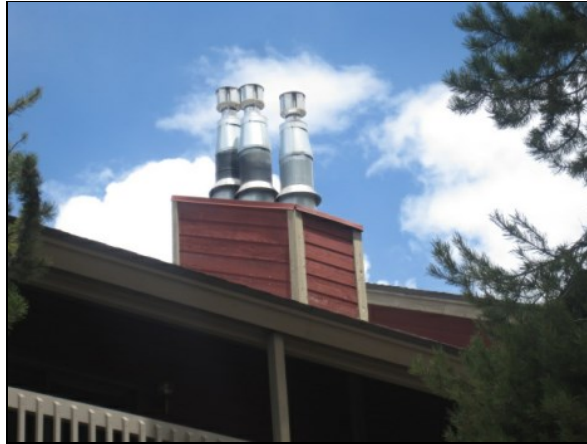
Useful Life:
25 years

Remaining Life:
23 years

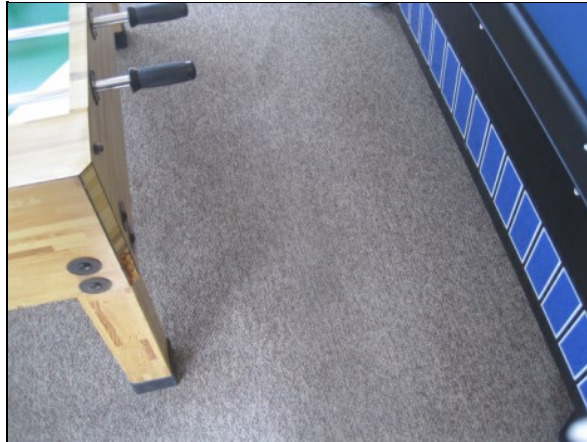
Useful Life:
10 years

Remaining Life:
7 years

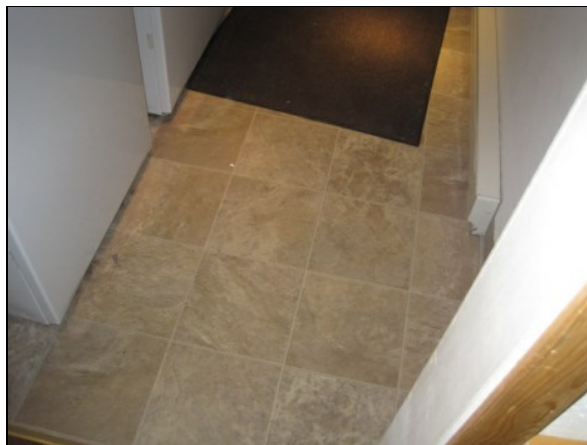
Useful Life:
20 years

Remaining Life:
8 years

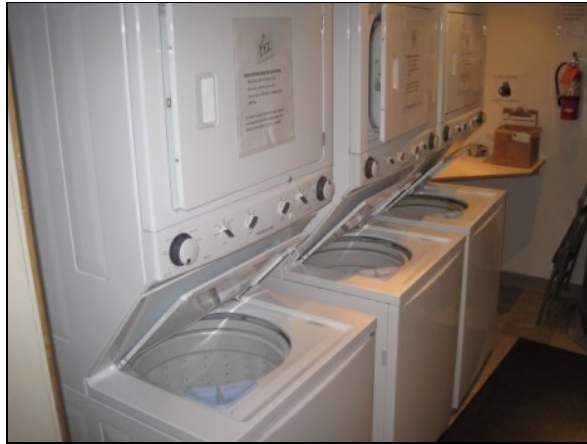
Useful Life:
15 years

Remaining Life:
9 years

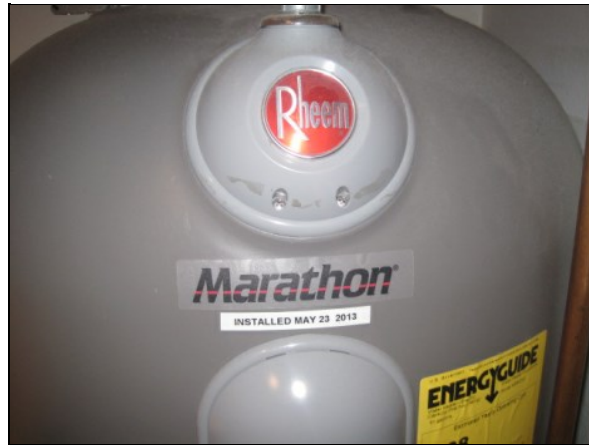
Useful Life:
15 years

Remaining Life:
9 years
